Case Study

Monitoring Power Quality Beyond EN 50160 and IEC 61000-4-30

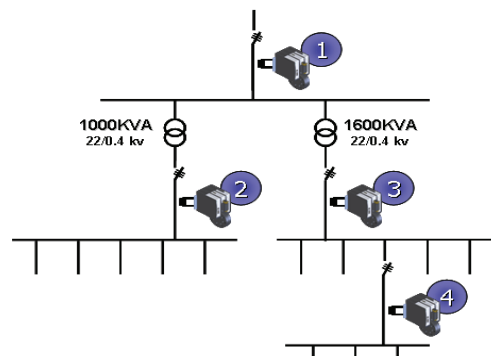
Figure 2: Single Line Diagram with Elspec G4420

Four Elspec G4420 Power Quality Data Centers were installed at the main service, at the secondary of each transformer and at one of the MCC with many reported failures (hereinafter named 1, 2, 3 and 4 as showed at Figure 2). Each device utilized the patented PQQIP compression technology, providing typical 1000:1 compress ratio, to record onboard all the data at 512 samples per cycle for a few months.

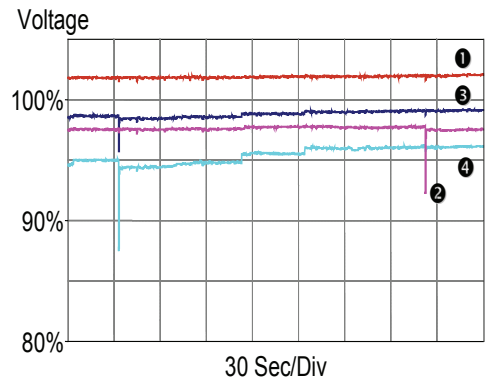
Figure 5: L2 Voltage at 4 Locations

One of the main benefits of using PQZIP compression technology and continuous storing of all information at high resolution is the ability to monitor events at several locations synchronized by time. Figure 5 shows the phase L2 to neutral voltage at all 4 locations. Only the voltage dip at 4 was more than the commonly used 10% threshold. When using a trigger-based logger, the troubleshooting engineer would have only a few cycles before and a few cycles after the event, from location 4 only. The data from the other three locations wouldn't be logged. Therefore, it would be difficult to understand the event propagation over the network.

Figure 5 shows the L2 voltage on all locations. It shows two events – on the left side an event started from 4, to the transformer secondary (3), up to the primary (1) and down to the other's transformer secondary (2). However, the event on the right did the opposite: from 2 to 1 and down to 3 and 4. The lack of additional measurement points prevents better analysis of the source of failure and how to prevent it from reoccurring.

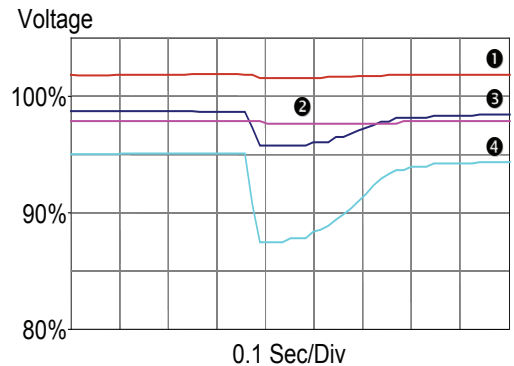
Figure 6: L2 Voltage Zoom

Figure 6 zooms in on the first event, showing the event propagation by time, in addition to the levels analysis done above.

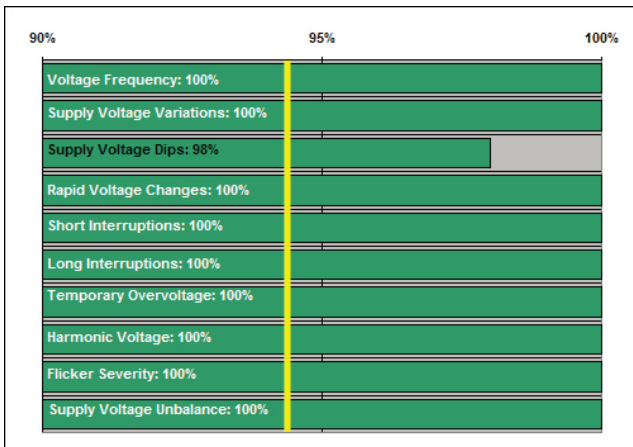
Figure 3: EN 50160 at the Main Service

Figure 3 shows the results of EN 50160 compliance at the main service (1). Similar results were measured at each one of the transformer secondary (2 & 3). The site not only complies with the standard, it is even exceeds it.

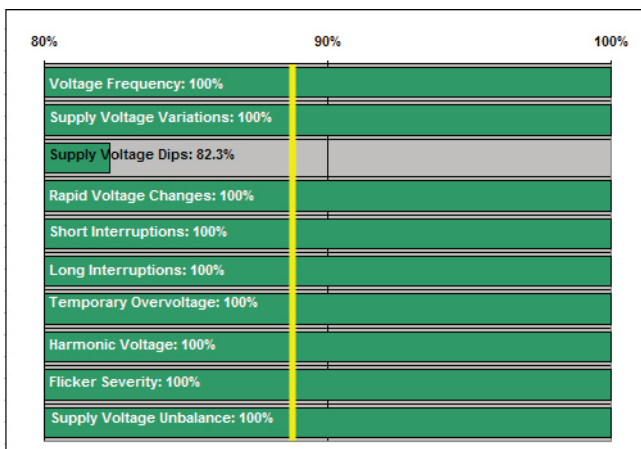
Figure 4: EN 50160 at MCC

Figure 4 shows the EN 50160 results at the MCC (4), where many faults were observed. However, similar faults occur in points 2 and 3 as well, which perfectly comply with EN 50160. The obvious conclusion is that compliance to EN50160 cannot provide the answer to the source of failures, although it indicates existence of voltage dips in one location.

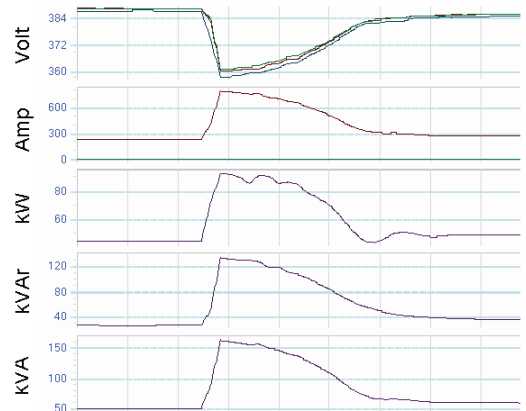
Figure 7: Typical dip at MCC

Figure 7 shows the voltages, currents, kW, kVAR and kVA trends of a typical dip at the MCC (4) which allows for deeper investigation. It clearly shows that the dip is caused by a motor startup, and it can easily be compensated for by using the Elspec Equalizer – the world's fastest reactive power compensation system. However, since these dips occur every few minutes, it is not likely the source of the repetitive failures. Moreover, similar failures occur at locations where the dips are significantly smaller.

- There are voltage dips in each one of the transformers.
- These dips can be reduced by using Elspec Equalizer.
- These dips happens all the time and they are not the source for the repetitive failures.
- Further investigation is required in order to locate the reason for the repetitive failures.

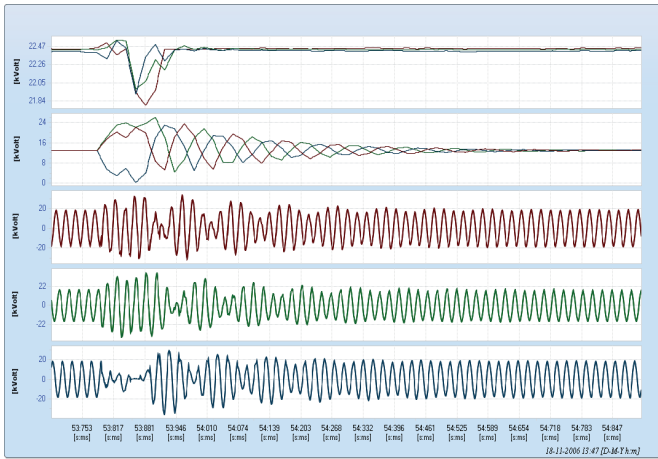
Figure 8: Line-to-Ground Event

The site is connected using two Delta/Wye transformers. Since the voltage supply is Delta, the measurements are commonly limited to line-to-line voltages only. This is also what is required in the different standards and regulations. Elspec G4400 analyzers record all the information all the time, including line-to-neutral values. When the network is Delta, and the neutral is not connected, the line-to-neutral values are the line-to-ground ones. One of the benefits of the additional measurements is shown in Figure 8. Due to a short circuit between phase L3 to the ground, the line-to-ground voltages spiked to 26kV, rather than the nominal 12.7kV (changes from 0% to 205%). During the same failure, the dip on the line-to-line voltage was less than 1% from nominal and 3% from the steady state level (21.8kV with respect to 22.0kV and 22.4kV).

The technical justification for monitoring only the line-to-line voltages is that the line-to-ground voltages do not go through the transformer since it is D/Y. However, the over-and-under voltages do affect the transformer itself and reduce its

life expectancy. Moreover, in sites where there are medium voltage (MV) loads, this voltage can cause significant damage to the loads as well.

- The solution can be from both sides of the meter – the utility can improve its grid and/or the customer can install better lightning arrestors.
- This phenomena affects the MV only, and it is not the source of the failures.
- Further investigation is required in order to locate the reason for the repetitive failures.

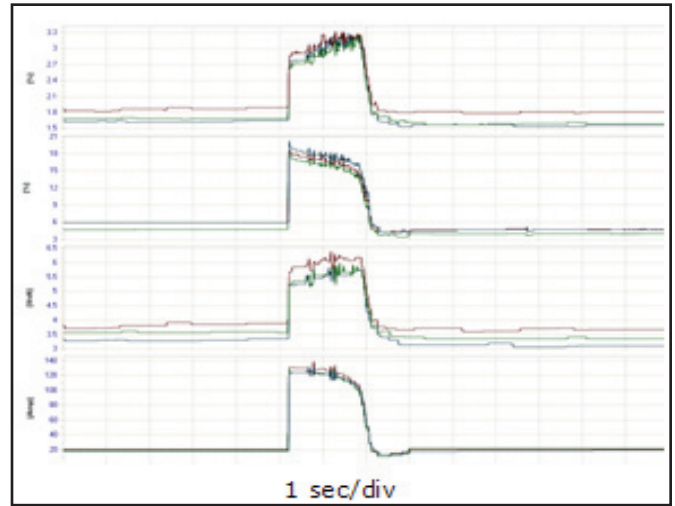
Figure 9: THD and 5th Harmony

The site includes many generators of harmonic pollution, mainly the 5th harmonic. The loads generate harmonic current which create voltage pollution. Figure 9 shows a typical condition - maximum 3.3% THD V, maximum 20% THD I, 6.5V and 140A at 5th harmonic.

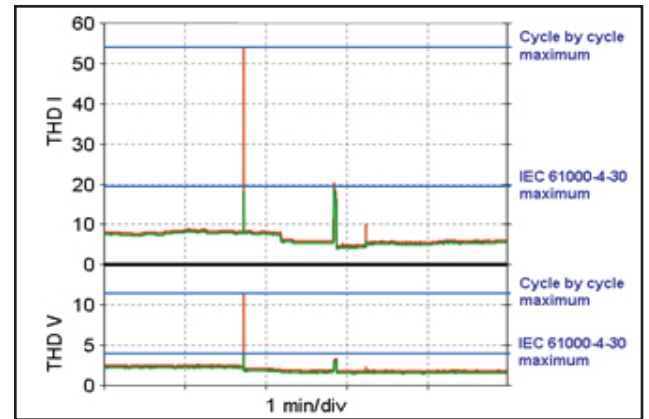
Figure 10: Cycle-by-cycle and IEC 61000-4-30 THD

However, this averaging may hide shorter phenomena. In some cases, short events don't have the required energy to cause damage. However, it depends on the weakness of the most sensitive device. Figure 10 shows the different results of the voltage and current THD when calculating every cycle (red) and according to IEC 61000-4-30 (green). Rather than maximum current THD of 19%, the true value is 53%. Similarly, the voltage THD is 12% and not 4%.

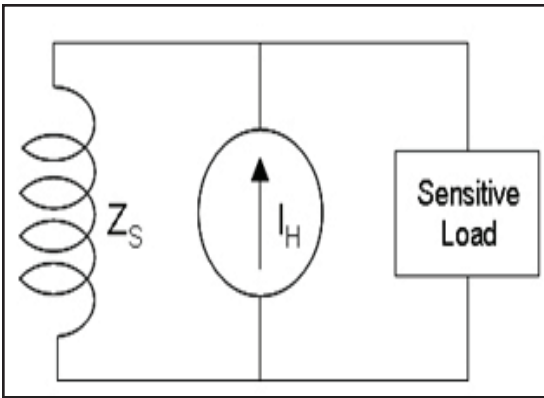
Figure 11: Simplified Network Representation at 5th Harmony

Due to superposition, the network is represented at the 5th harmonic differently than in the fundamental (Figure 11). The load functions as current source (IH). Normally, the network equivalent impedance (Zs = ZSOURCE = utility network plus transformer) is the lowest, and the harmonic current flows to the utility network which can withstand the

pollution. However, in some cases the network impedance is increased (e.g., connection or disconnection of capacitors) and the harmonic current flows to the lowest impedance, which is a sensitive load. In addition, due to the increased impedance, the current source cannot supply the same amount of current, and during this resonance the current is smaller.

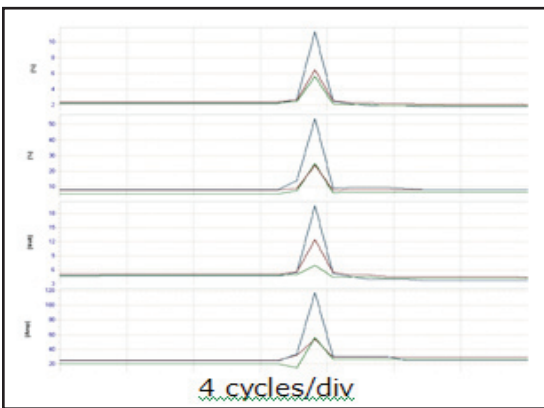
Figure 12: Temporary Resonance

Normally, harmonics are averaged because the importance is the total energy in the harmonics. In this case, the peak power of this resonance is 3kVA (Figure 12). Obviously, the 200 ms average is less, but it was still enough to cause damage. Moreover, sensitive loads probably fail before the 200 ms period is over.

- The source of failure is probably due to temporary resonance at 5th harmony
- To prevent the failures, a fixed passive filter is required

To prevent the resonance, a passive filter should be used. The filter should have low impedance at the 5th harmony and be installed as close as possible to the transformer.

Karpri installed two Elspec fixed, passive filters tuned to the 5th harmony (tuned to 235 Hz). After the installation of the filters, no additional failures were reported. Moreover, some of the loads that were disconnected when not in use in order to protect them, were left connected continuously.
